Fire Station Roof Repair

Replace EPDM (ethylene propylene diene monomer) rubber roof (Permanent Building Committee (PBC) – Priority Project)

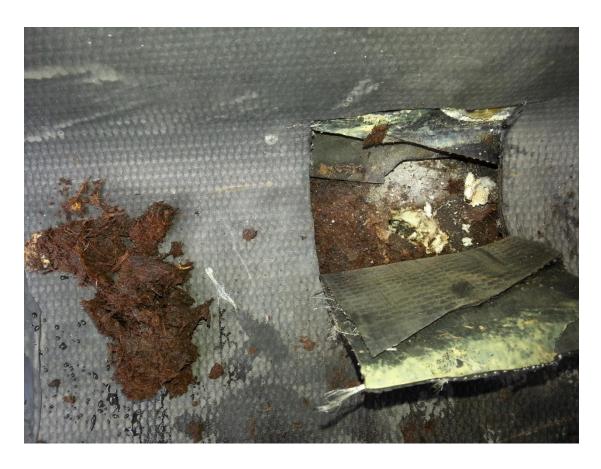
Roofing System Failure Saturated Insulation and Decking Dispatch Roof Cut (2013)

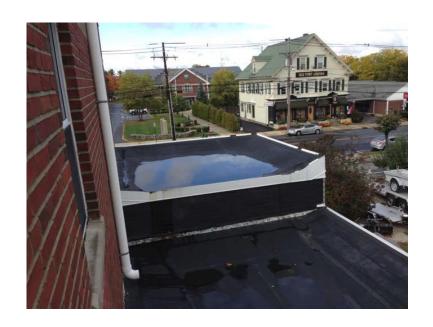
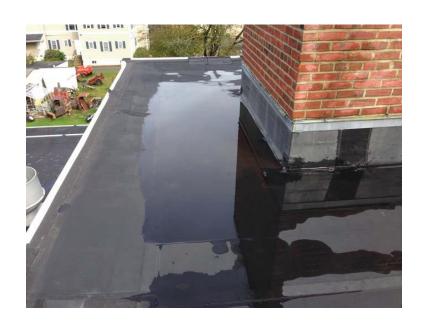
Roof System Failure (Ponding) Lack of Proper Slope

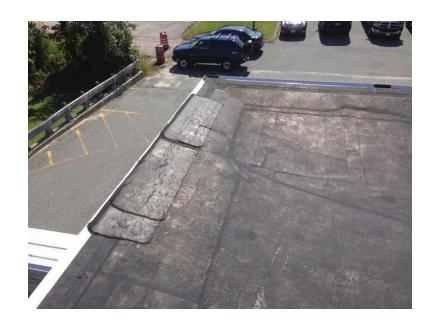
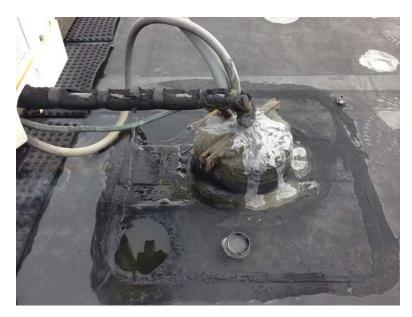
Roofing System Failure Patches and Seals

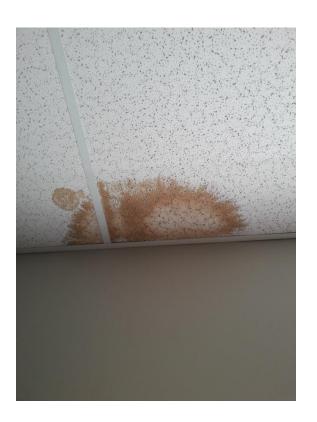
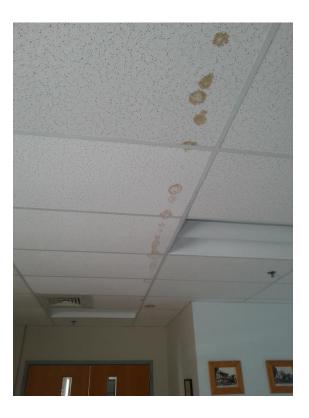
Ceiling Tiles (2013) Stained Throughout Building

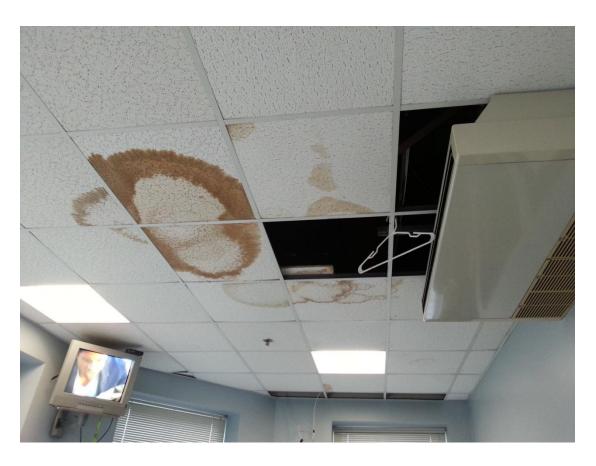
Dispatch Ceiling Tiles (2014) Missing and Stained Tiles
